Stains on light-coloured quartzite: What to do?

Quartzite as kitchen countertops?

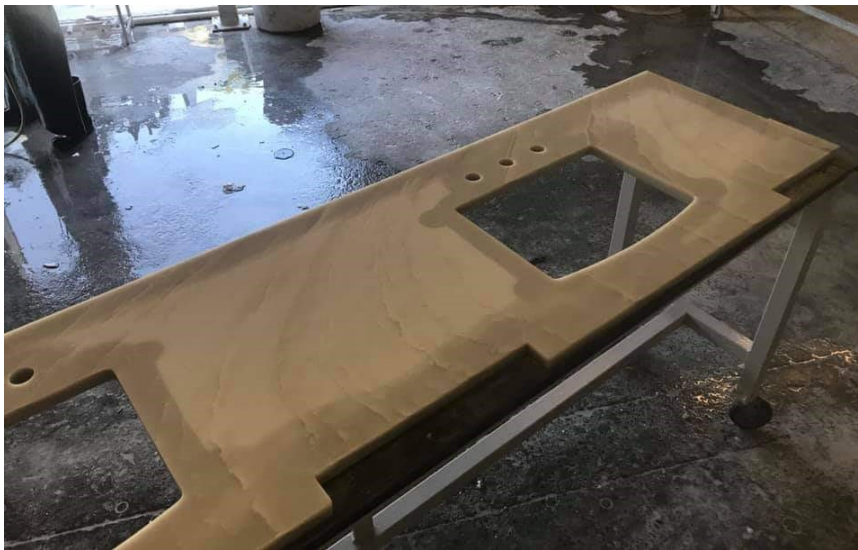
Fig. 1: Edge staining caused by absorption of moisture after water jet cutting

Moisture gets into the countertops through various cutting and drilling processes (e. g. water jet cutting). Normally, thanks to their porous structures, natural stones dry by allowing the penetrated moisture to rise vertically and horizontally to the stone surface and then to evaporate. Only when the stones are absolutely dry, a subsequent protective treatment can be started. However, quartzites behave differently. Due to their very dense, finely developed pore system in the stone layers, moisture often only penetrates via the cut edges, resulting in a visible darkening of the edge surfaces (see Fig. 1).

The absorbed water can hardly rise up vertically to the stone surface due to the strong capillary forces caused by the fine pores. Basically, the smaller the pore size, the more pronounced the capillary force is. In addition, many quartzites are resin coated on the surface already on the factory, which complicates the process described above even more. The moisture can therefore only leave the stone very slowly in the direction of the cut edge. As a result, quartzites require a comparatively higher drying effort (e. g. through active drying in drying ovens or hot air drying), which can also last longer (several days or even weeks).

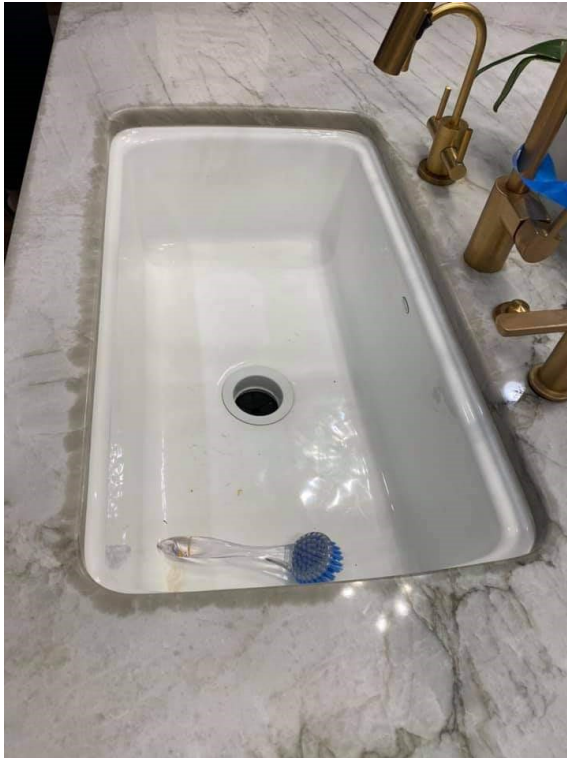
Fig. 2: Stain pattern at the cut surfaces in the sink area

Kitchen countertops and bathroom vanity tops that had already been installed showed a similar appearance, but only after about six to 24 months (see Fig. 2 and 3).

The tests showed that the darkened edges were most likely caused by regular cleaning. Wiping cloths soaked in detergent and dissolved cooking oils (kitchen) / cosmetic oils (bathroom) are often used to clean the surfaces and edges. While the surfaces of quartzites are usually resin-coated and thus almost impermeable to water, moisture and dissolved fat components can penetrate the stone at the untreated edges. With each cleaning process, small amounts of a water/oil/surfactant mixture penetrate into the stone and accumulate there. If a critical quantity of this so-called emulsion is reached, edge staining occurs. The series of tests carried out by the application technology department with numerous cleaners showed that these stains can hardly be removed chemically, which means that they must be classified as permanent at the present time. Although in some cases the stains could be removed by heating with a burner flame, this method involves high risks regarding the formation of cracks or discolouration on the stone surface (especially for the resin-treated stones).

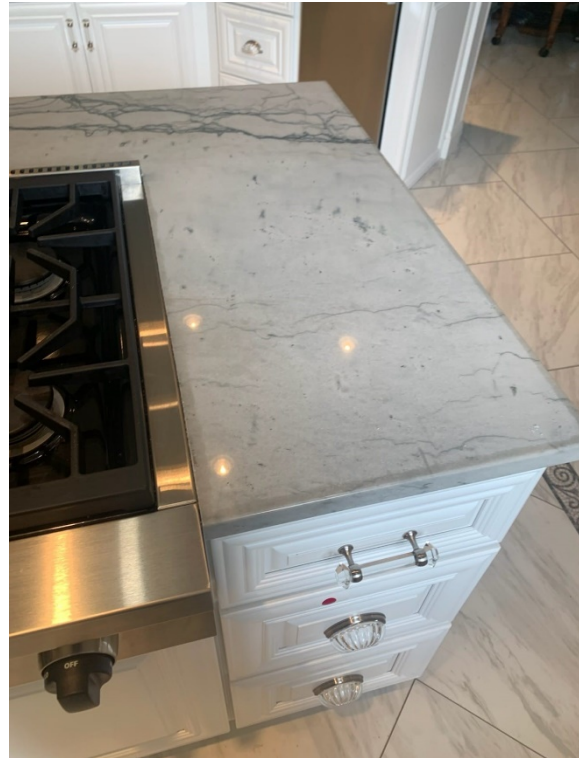
Fig. 3: Edge staining occurring after a few months
